SAMPLE REPORT

INFRARED INSPECTION REPORT

SDMYERS

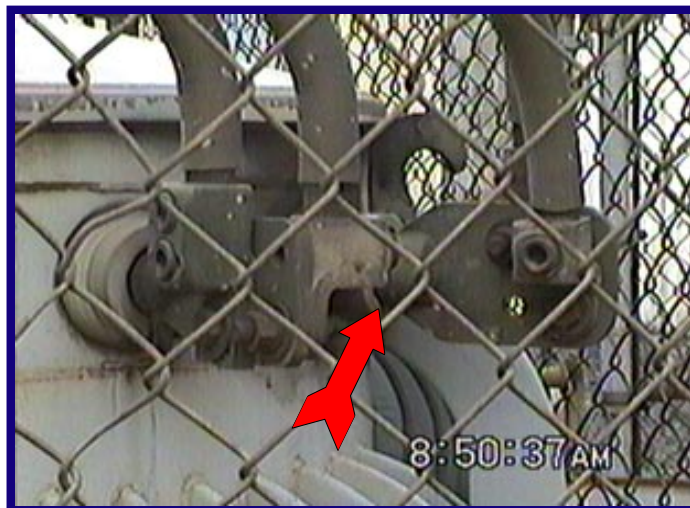
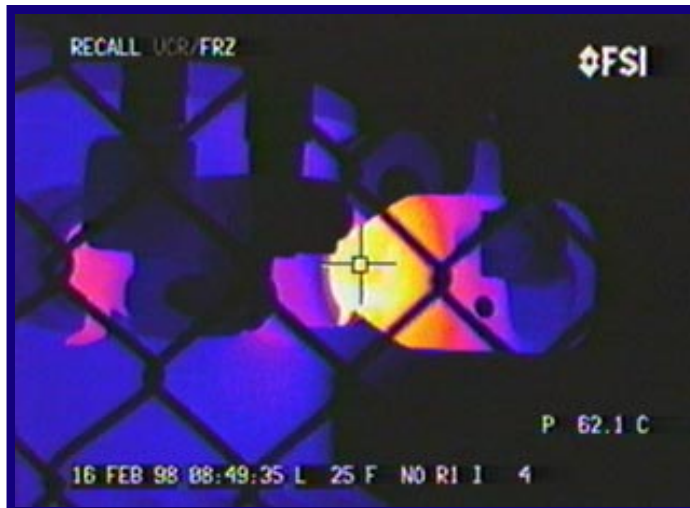
B Phase 500KVA Transformer
Secondary Bushing
TC# 14

Defective bushing and/or loose
internal connection

The A Phase = 38c
The B Phase = 62c
The C Phase = 37c
The Delta-T = 25c
Ambient = 18c

Critical Potential

Inspect the bushing and
internal connections: Repair
or replace as required

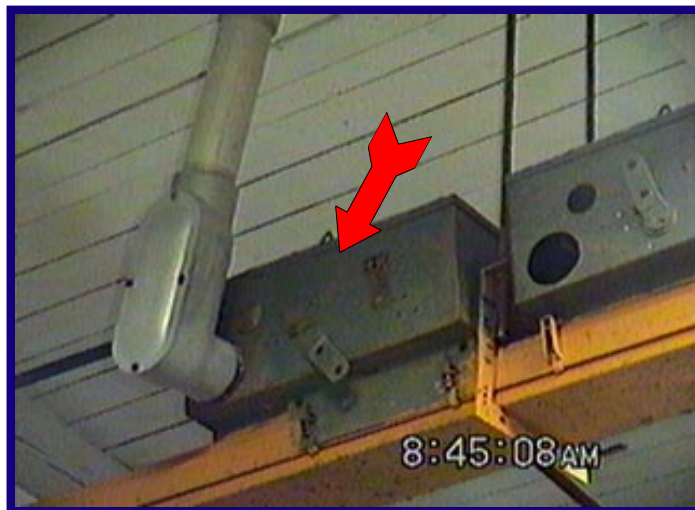
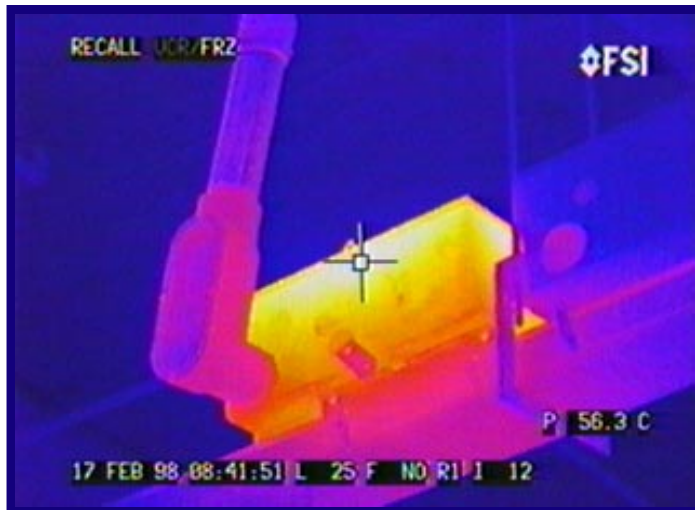
Buss Junction Box for the
302 Package Machine

Suspect an internal problem

The Junction Box = 56c
Internal Temp is Unknown
Ambient = 21c
Rise Above Ambient = 35c

Serious Potential

Inspect for cause of heating and
repair or relace as required

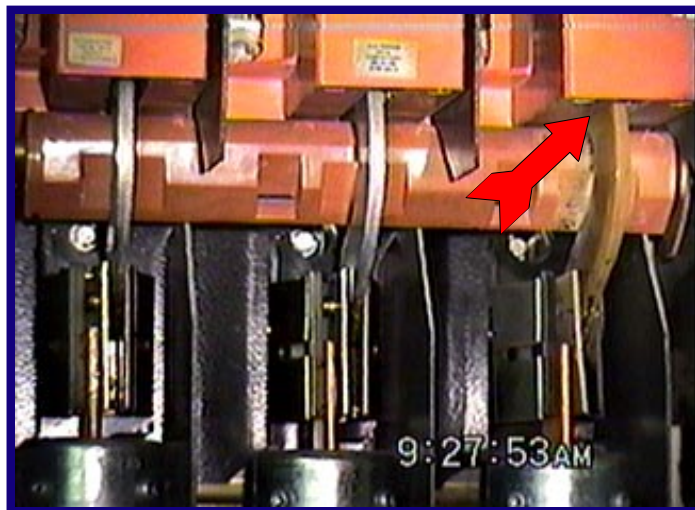
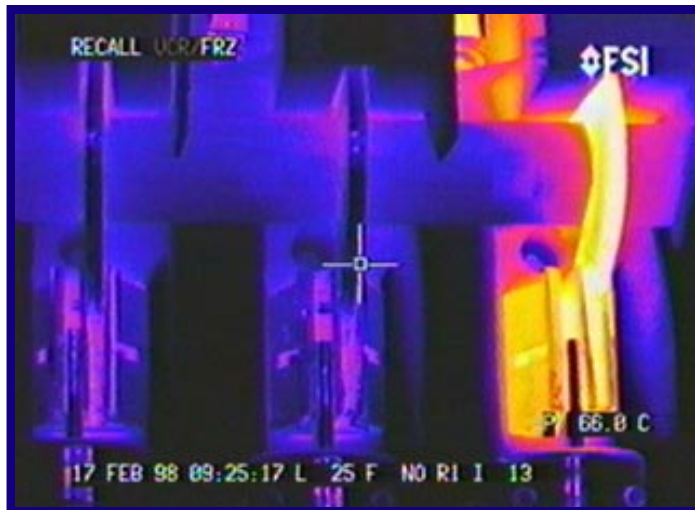
Main Fused Disconnect for the
1 Air Compressor, C Phase,
Line Side, Contact Assembly

Loose/deteriorated disconnect/
fuse component(s)

The A Phase = 32c
The B Phase = 32c
The C Phase = 66c
The Delta-T = 34c
Ambient = 22c

Intermediate Potential

Clean, Align and tighten all
contacting/connecting points of
the disconnect assembly

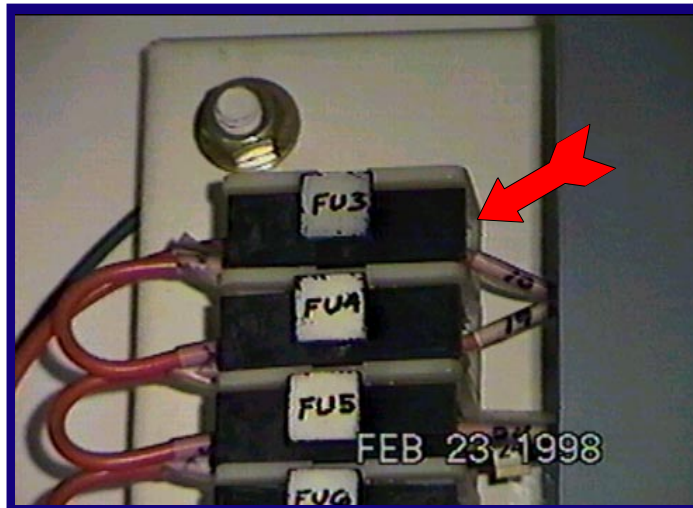
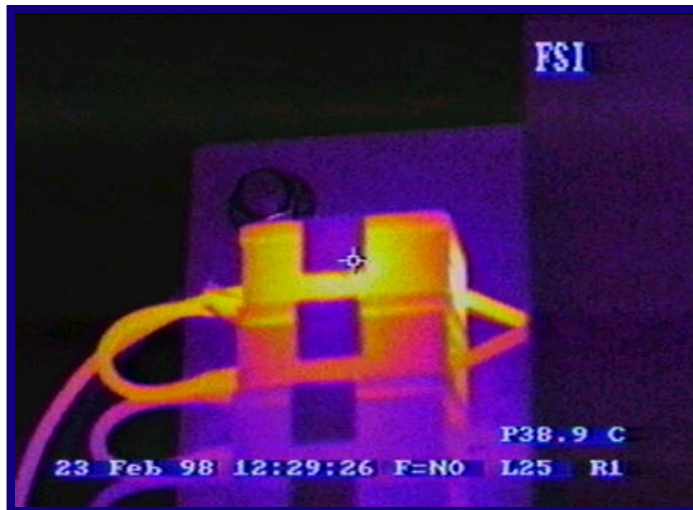
Control Panel for Mylar Seal
L-26 (MS-113), Fuse # FU3
Right Side

Loose/deteriorated fuse clip,
blade, or jaw assembly

The Right Fuse Clip = 39c
The Left Fuse Clip = 26c
The Delta-T = 13c
Ambient = 21c

Minor Potential

Replace the fuse clips

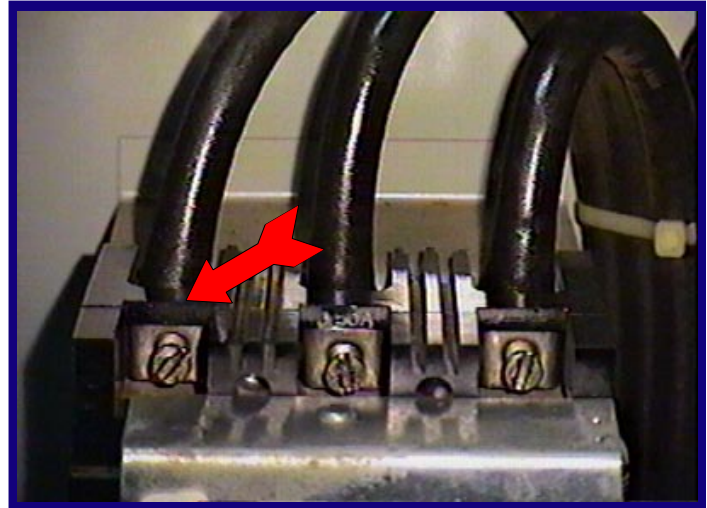
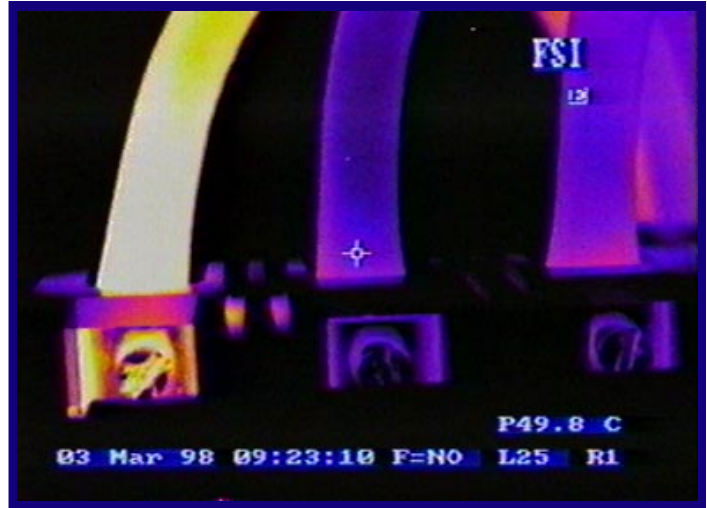
Control Panel for Cooling Tower,
Line # 1 - Pump P-911A
Main Breaker, Line Side,
A Phase

Loose/deteriorated connections

The A Phase = 50c
The B Phase = 29c
The C Phase = 29c
The Delta-T = 21c
Ambient = 14c

Intermediate Potential

Check for dead wire (Oxide buildup between strands) and cut back cable if required: Clean and tighten the connection
